Your survey report

Inspection Date

11th January 2023

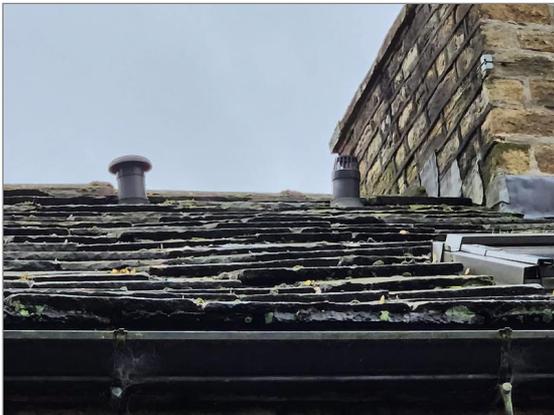
Photo - 1 Soil vent pipe and bathroom extractor which pass through the rear roof slope.

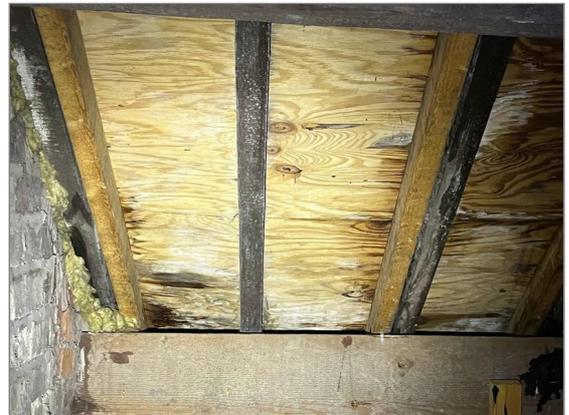
The roof benefits from a timber secondary waterproof layer (sarking board) which is on the whole in satisfactory condition however the damp affected sections will require replacement as part of the roof refurbishment.

Photo - 2 Damp secondary water proof layer (sarking board).

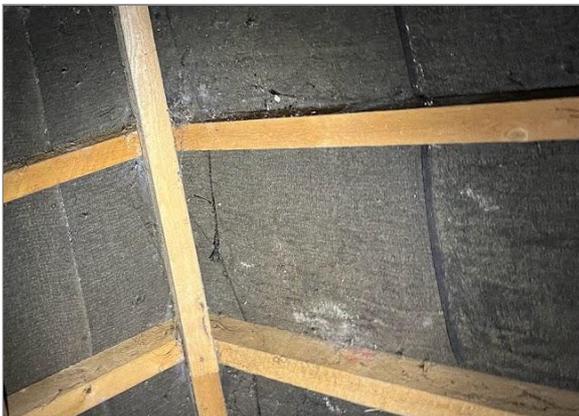
The secondary waterproof layer (roofing felt) is in fair condition.

Photo - 3 Rear addition / utility room secondary waterproof layer (roofing felt).

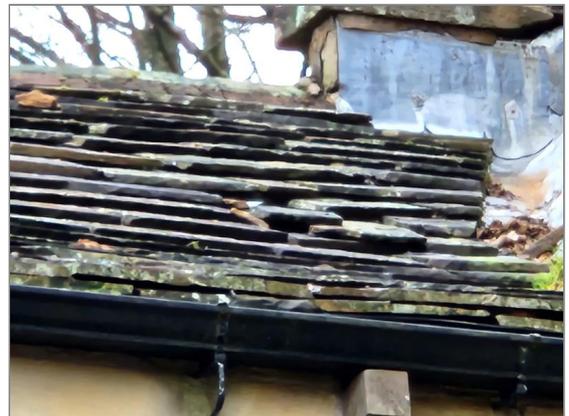
The original stone slate roof coverings to the main roof slopes are now nearing the end of their life expectancy with signs of significant age and weathering with missing, chipped, slipped and crumbling slate noted which will need repair. There is evidence of damp staining to the timbers in the loft area indicating that the roof is not watertight (see section E1). The roof void also lacks adequate ventilation which will need to be addressed (see section E1).

Photo - 4 Slipped slates / loose pointing

Whilst routine maintenance and patch repairs could be carried out to ensure the roof remains watertight, the costs of regular repairs to an old roof will mount, and it will probably make economic sense to consider refurbishing the roof coverings (I would anticipate that many of the existing stone slates could be reused). You should obtain quotations from roofing contractors prior to purchase so the repair costs can be assessed and budgeted for.

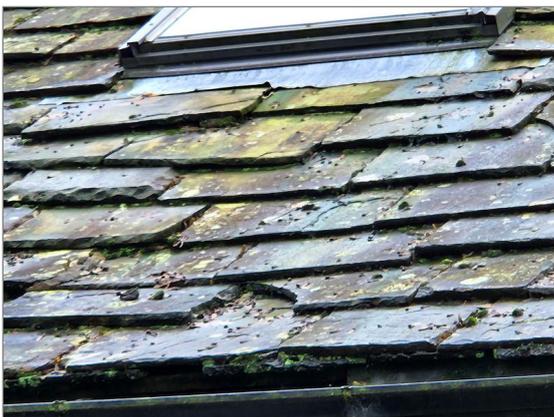
Photo - 5 Cracked slates on rear slope

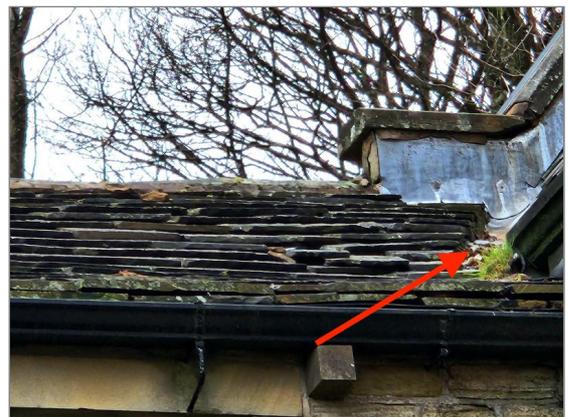
The sloping valley gutters on the front and rear main roof slopes are lined with lead. These are blocked with leaves and debris should now be cleaned out and checked as these types of lined gutters are vulnerable to leaks.

Photo - 6 Blocked valley gutter front

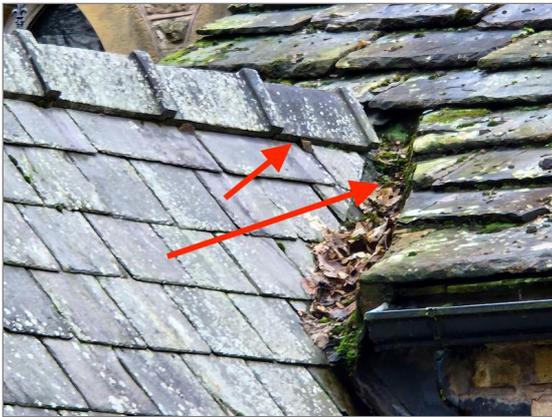
Photo - 7 Slates ok - localised pointing plus blocked rear valley gutter

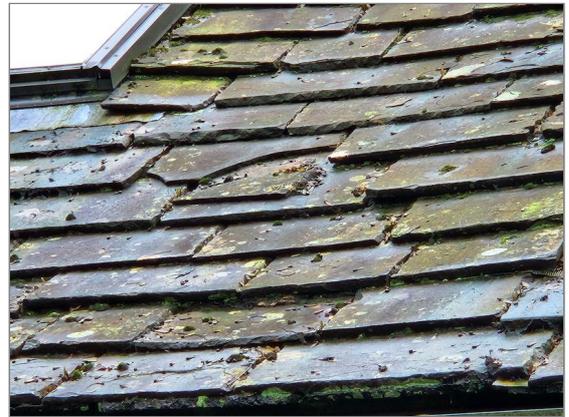
Photo - 8 Cracked slates at rear

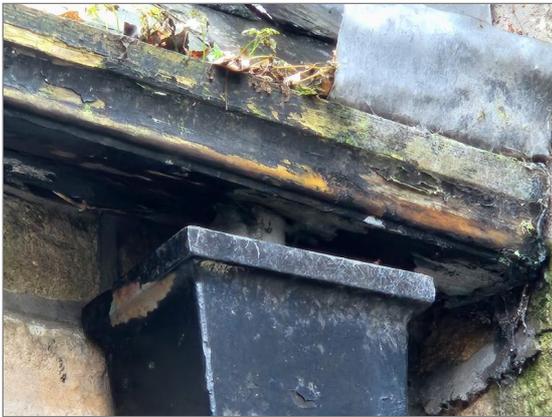
Photo - 9 Repair/replace timber gutter at rear

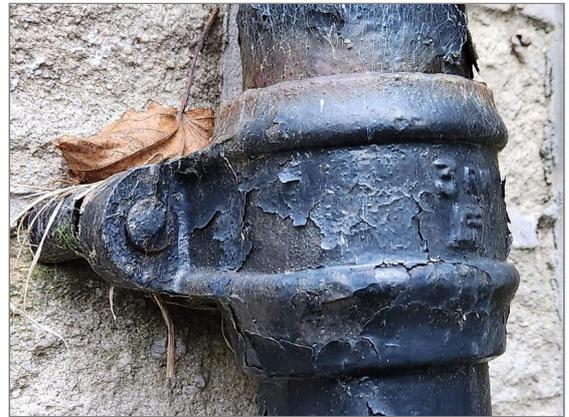
The original cast iron down-pipe and hopper head at the side of the rear kitchen door are rusted and will be prone to leaks and should be replaced. The timber gutter at the side of the hopper head is also dated and shows signs of deterioration and will need repair or replacement.

Photo - 10 Rusted rear downpipe

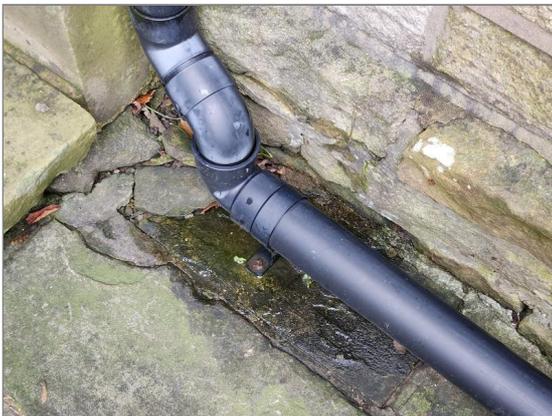
A small amount of ponding water was noted at path level beneath the horizontal section of down pipe at the side of the front door which suggests the joints / seals are defective and will need repair.

Photo - 11 Leaking downpipe at front door

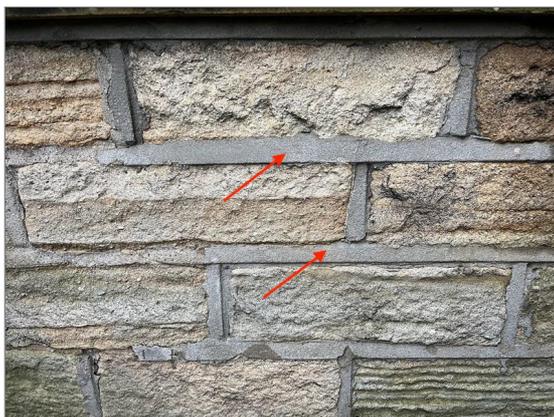
Ideally properties of this age and construction should be pointed with a lime based mortar to enable the walls to breathe and cement based mortar pointing was noted which can cause internal damp issues (see section E3). You should ask a suitable contractor for further advice before completing any repairs.

Photo - 12 Cement based mortar pointing.

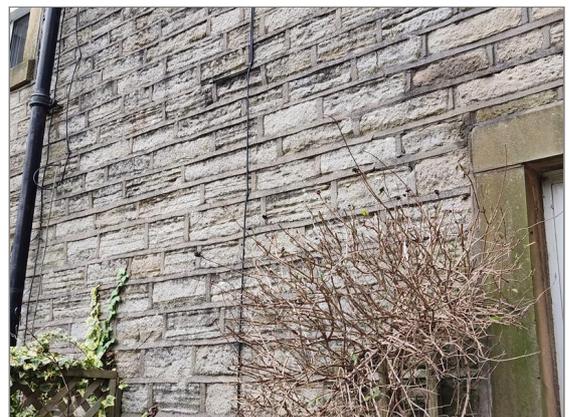
The property is constructed 580mm thick solid stone walls and is structurally sound with no evidence of any significant ongoing movement or other structural defects.

Photo - 13 Walls structurally sound and in fair condition for age

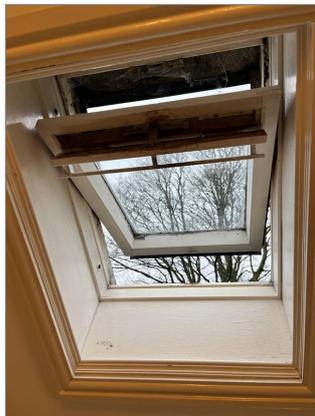
Photo - 14 Bathroom Velux rooflight.

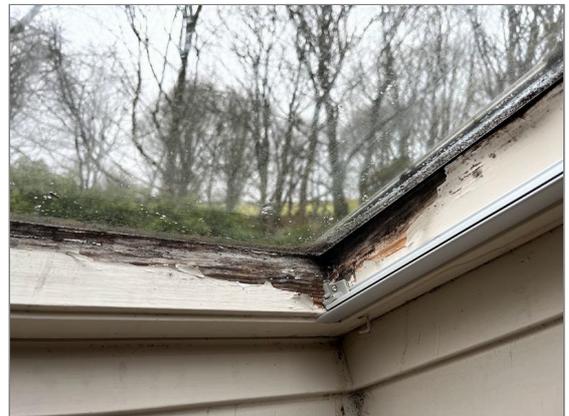
The Velux rooflights in the rear elevation have been neglected and will require treatment with a proprietary wood care product to prevent further deterioration of the frames. The rooflights both functioned when tested.

Photo - 15 Rear bedroom Velux rooflight - neglected.

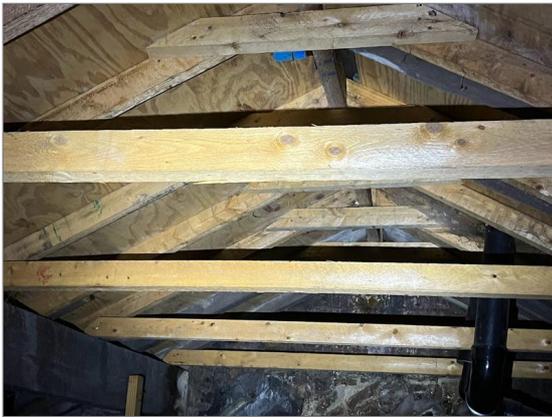
Many of the timber rafters have been replaced and the main front purlin has been repaired with an additional timber bolted to the original purlin. Whilst these works look to have been completed to a satisfactory standard your legal adviser should ensure that building regulation approval (including the issuing of a final completion certificate) was granted for these works (see section H1).

Photo - 16 Roof structure - replacement timbers.

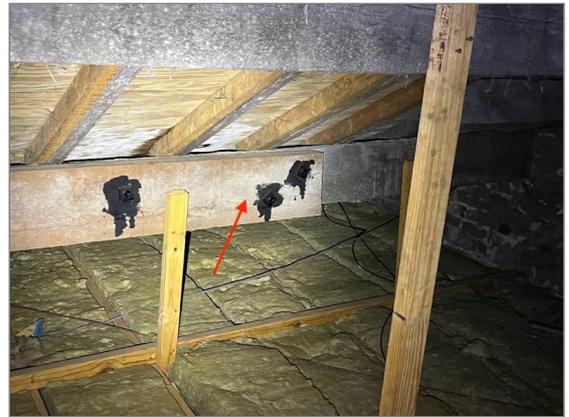
Photo - 17 Roof structure - replacement purlin arrowed.

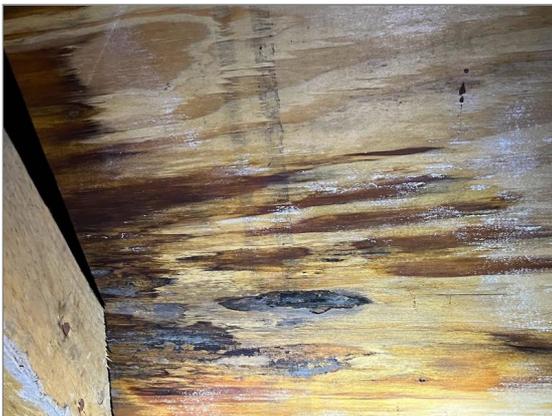
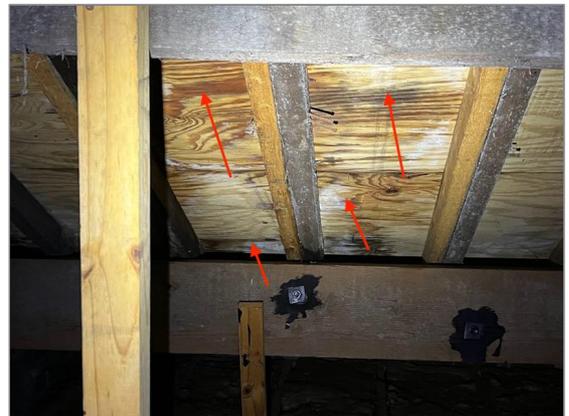
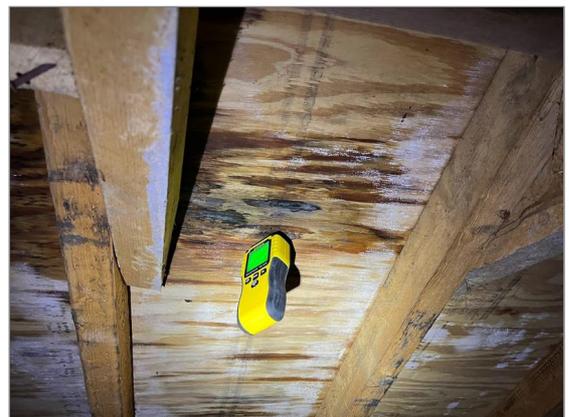
Some damp staining was noted to the timbers and sarking board which provides a secondary waterproof layer and it appears the roof is not fully watertight. The timbers should be checked at close quarters to see if treatment is required and if the timbers are affected by rot or other timber defects. The cause of the water penetration needs to be identified and appropriate remedial works carried out (see section D2). The damp affected sections of sarking board should be replaced during the refurbishment / repair of the roof coverings (see section D2).

Photo - 18 Damp penetration.

Photo - 19 Damp penetration.

Photo - 21 Damp penetration.

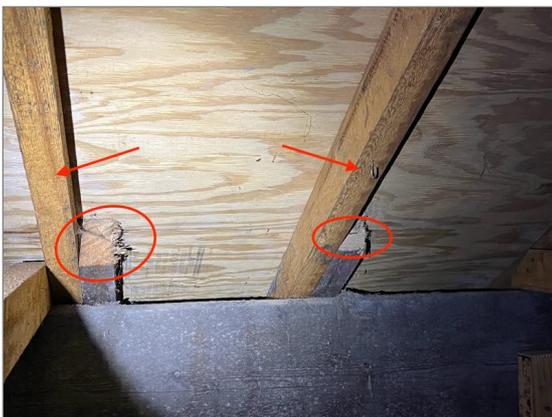
Photo - 20 Replacement rafters (arrowed) and originals cut short (circled).

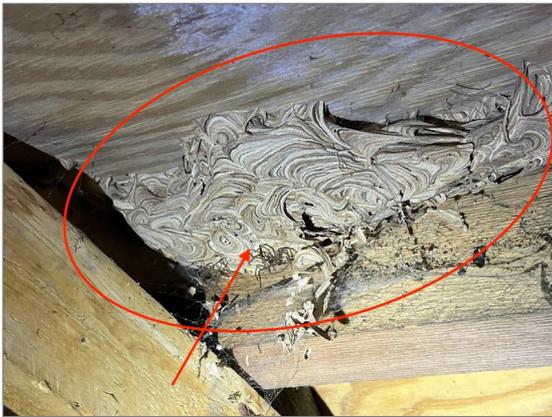
Photo - 22 Wasps nest.

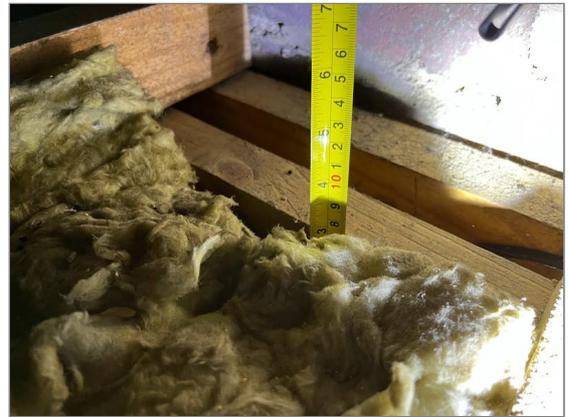
The level of roof insulation included within the EPC is incorrect and may affect the energy efficiency rating and recommendations.

Photo - 23 Loft insulation (main loft) - approx 80mm

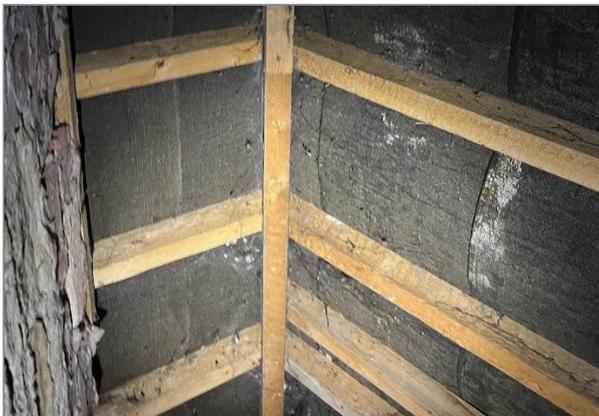
The rear addition / utility room roof is constructed of timber and is in satisfactory condition.

Photo - 24 Rear addition / utility roof structure and secondary waterproof layer (roofing felt).

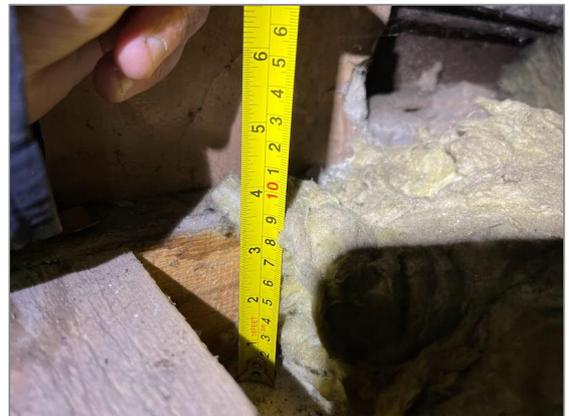
Photo - 25 Rear addition / utility room loft insulation - approx 90mm.

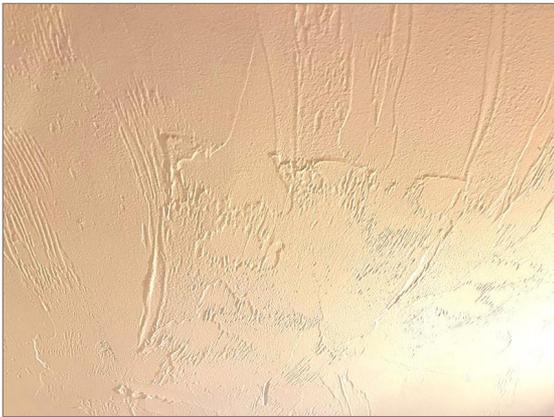
A textured decorative coating covers the kitchen ceiling. This type of coating may contain small amounts of asbestos fibres and if disturbed, they could be a safety hazard (see section I3). If the ceiling requires extensive repair or replacement, you will have to use a contractor experienced in this type of work or an asbestos specialist.

Photo - 26 Textured ceiling coating.

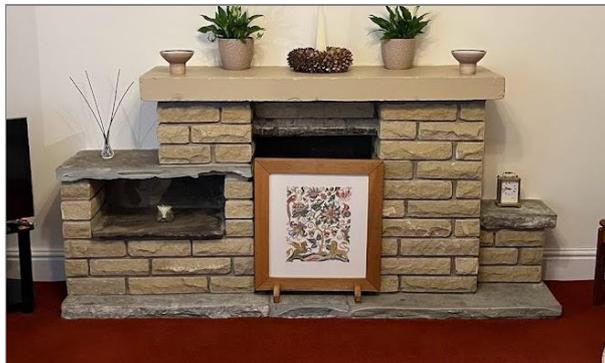
The property includes a decorative stone fire surround in the main reception room which, whilst somewhat dated, is in satisfactory condition. The property does not include a chimney breast or flue.

Photo - 27 Decorative stone fire surround.

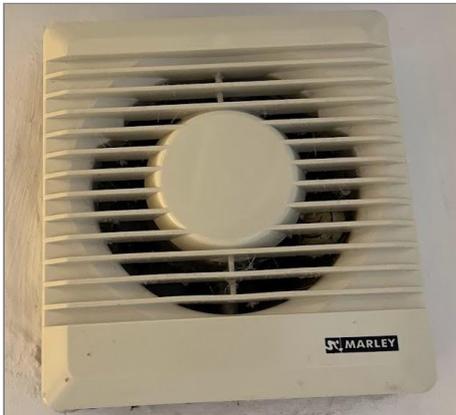
The extractor fan in the bathroom vents through a pipe which passes through the loft and rear roof slope. The fan functioned correctly when tested.

Photo - 28 Bathroom extractor.

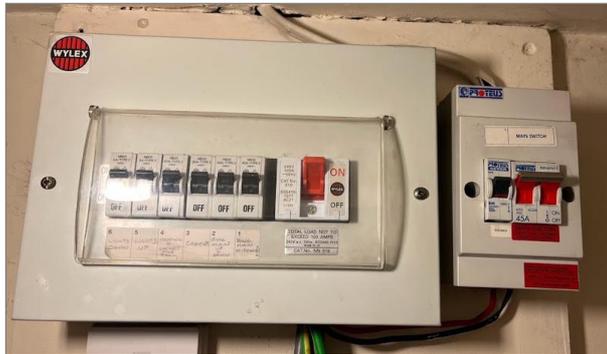
Photo - 29 Dated consumer unit - no RCD protection.

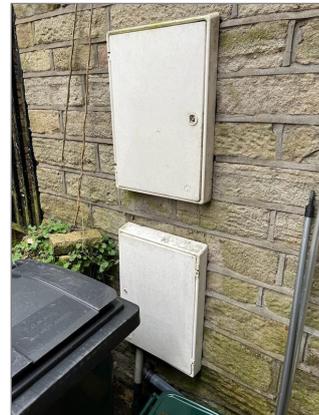
Photo - 30 External meter boxes.

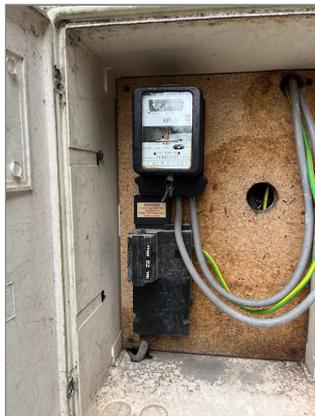
Photo - 31 Electricity meter and incoming supply.

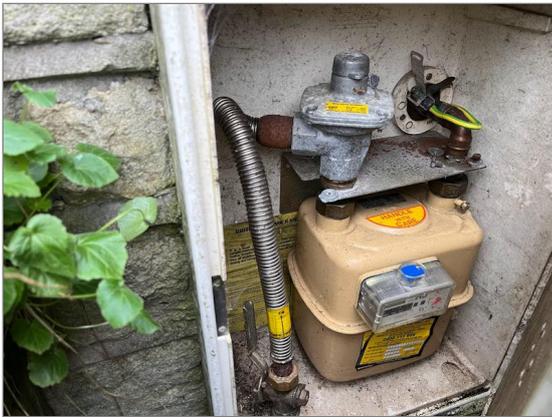
Photo - 32 Gas meter.

As a precautionary safety measure, the gas supply and installation should be tested by a qualified gas engineer.

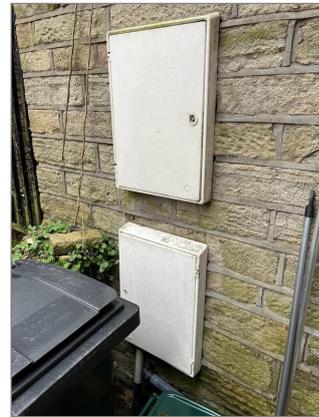
Photo - 33 External meter boxes.

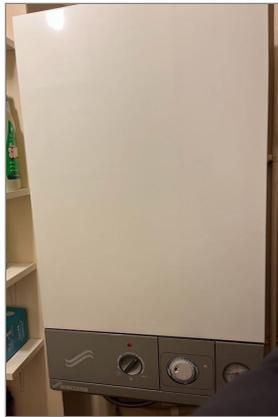
The boiler is not a condensing style boiler which would indicate that it was installed prior to 2005 and therefore probably nearing the end of its life expectancy. You should budget for its replacement over the short to medium term.

Photo - 34 Central heating boiler.

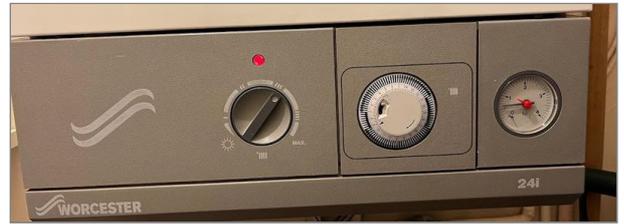
Photo - 35 Boiler control panel and model detail.

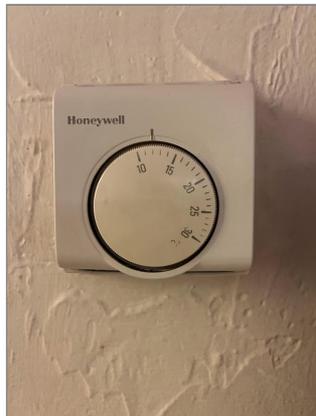
Photo - 36 Room thermostat.

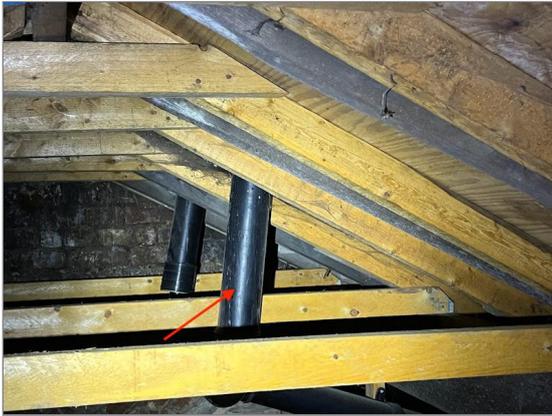
The soil vent pipe is internally located and passes through the loft and rear roof slope. Where visible it is in satisfactory condition. There were no obvious signs of leakage or other defects found adjacent to where the pipe is positioned inside the property.

Photo - 37 Soil vent pipe visible in loft.

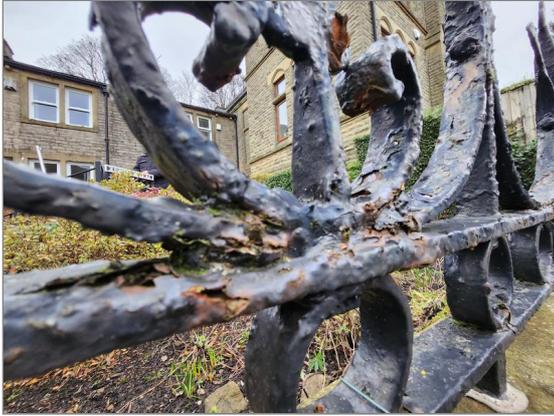
Photo - 38 Railings rusted at front

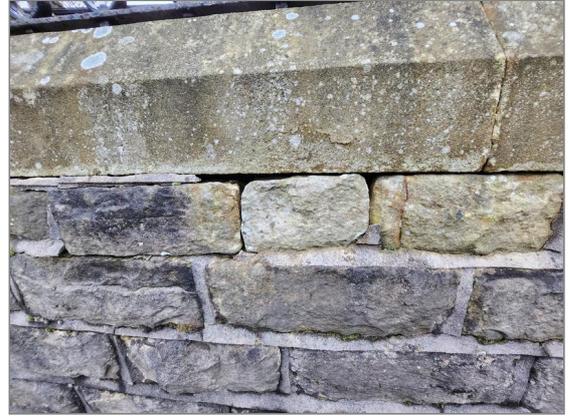
Photo - 39 Localised pointing to front retaining wall
